Service Hints

Video Cassette Recorder

Z-MECHANISM CHASSIS

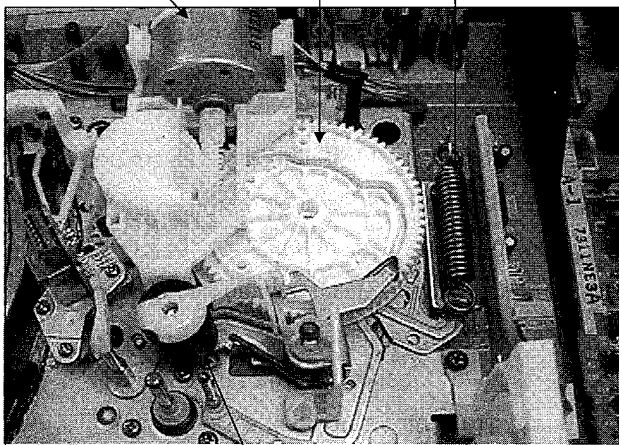
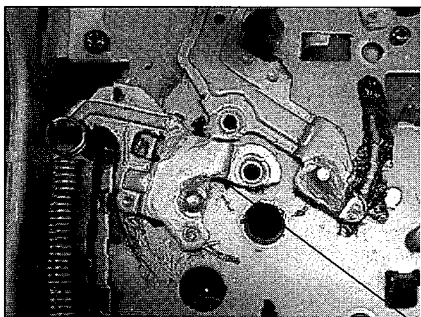
Parts location

Cassette tape floats during loading

Deformation of Drive rack arm located under Main cam gear

Replacement of Drive rack arm (VML3165)

1. Remove Mechanism unit.
 - Remove 5 screws that fix Mechanism unit.
 - Disconnect some connectors.
 - Remove Mechanism unit.
2. Remove Pinch arm unit.
 - Unlock the tab of Opener piece and remove Opener piece.
 - Remove Pinch arm unit.
3. Remove Loading motor unit.
 - Unlock 3 tabs of Loading motor unit and remove Loading motor unit.
4. Remove Main cam gear.
 - Remove Snap washer located at the bottom of Mechanism chassis and remove main cam gear.
5. Remove Drive rack arm.
 - Rotate Drive rack arm to the counterclockwise and remove Drive rack arm.
 - Then replace Drive rack arm.

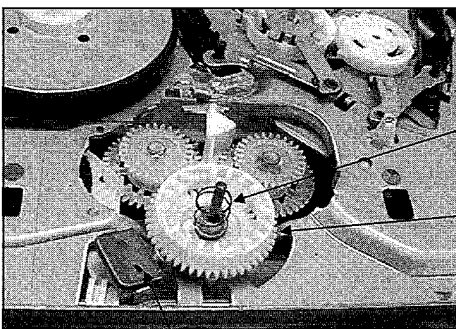
Parts location

Mis-function of Mechanism or abnormal sound in Mechanism

The rotation of Centre clutch unit is heavy

Centre clutch unit failure is thought. When rotate Centre clutch unit individually, the rotation of Centre clutch unit is uneven.

Replacement of Centre clutch unit (VXP1850 or VXP1732) No. of Centre clutch unit is different depend on the model No.

1. Remove Mechanism unit.
 - Remove 5 screws that fix Mechanism unit.
 - Disconnect some connectors.
 - Remove Mechanism unit.
2. Remove centre clutch located at the bottom of Mechanism chassis.
 - Remove Capstan belt and Washer and remove centre clutch unit while pressing conversion lever B to the bottom.After confirming the rotation of Centre clutch unit individually, replace it.

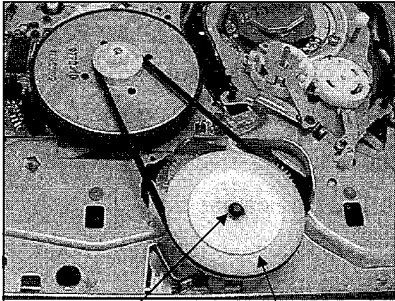
Parts location

Tape running is abnormal
or Abnormal sound in
Mechanism unit

Engagement between
Idler arm unit and Centre
clutch unit is not so good.

Engagement of gear of Idler arm unit is bad.

Replacement of Idler arm
unit (VXL2792)

1. Remove Mechanism unit.
 - Remove 5 screws that fix Mechanism unit.
 - Disconnect some connectors.
 - Remove Mechanism unit.
2. Remove Centre clutch unit located at the bottom of Mechanism chassis.
 - Remove Capstan belt and Washer.
 - Remove Centre clutch unit while pressing Conversion lever B to the bottom.
3. Remove Idler arm unit.
 - Remove Conversion gear and Conversion gear spring and remove Idler arm unit.

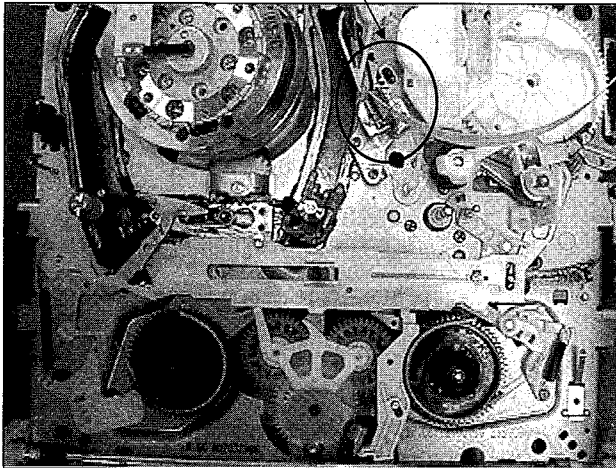
Parts location

A/C Head condition

Clog of A/C Head or
A/C Head failure

Since A/C Head is clogged and control signal is not detected, above phenomenon appears.

Cleaning of A/C Head or
replacement of A/C Head
(VED0412)

2. Clean the surface of A/C Head.

Remove 1 screw that fix A/C Head and replace A/C Head.

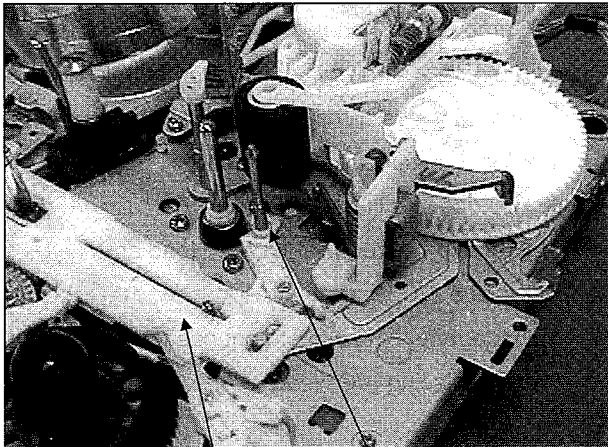
Parts location

Cassette tape does not move to cassette down position

Bend of P5 arm

The plastic portion of P5 arm is broken or P5 arm is bent.

Replacement of P5 arm (VXL2677)

1. Remove mechanism unit.
 - Remove 5 screws that fix Mechanism unit.
 - Disconnect some connectors.
 - Remove Mechanism unit.
2. Remove Main lever and P5 arm.

Unlock 2 tabs that fix LED prism and 1 tab that fix the projection on Mechanism chassis while lifting the left side of Main lever a little and remove Main lever and P5 arm. Then replace Main lever and P5 arm.

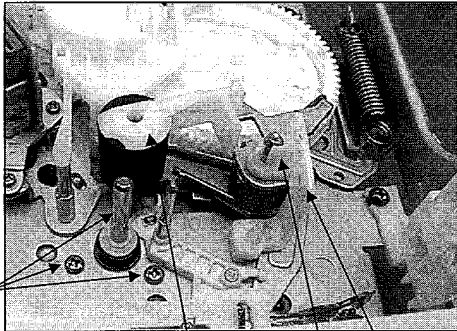
Parts location

Confirmation of the voltage for Hole element at pin 9 of IC0201 and Motor driving voltage at pin 22, 24 and 25 of IC0201

Replacement of Capstan unit (VEK8239)
The inside of IC0201 is broken and IC0201 is being supplied with Capstan unit as one unit

Capstan runs away so that cassette tape can not be ejected or VTR is placed to CUE mode even though VTR is set in SP playback mode.

1. Remove Top Panel and Front Panel unit.
 - Remove 2 screws located at both left and right side of Top Panel and Top Panel.
 - Remove 7 tabs located at top and bottom of Front Panel unit and Front Panel unit.
2. Remove Mechanism unit.
 - Remove 5 screws that fix Mechanism unit.
 - Disconnect some connectors.
 - Remove Mechanism unit.
3. Replacement of Capstan unit.
 - Unlock the tab of Opener piece and remove Opener piece. Remove Pinch arm unit.
 - Remove 3 screws that mount Capstan unit at the top of Mechanism unit.
 - Remove 2 screws that mount Capstan unit at the bottom of Mechanism unit.
 - Remove Capstan unit and replace capstan unit.
