Service Hints

Video Cassette Recorder

Z-MECHANISM CHASSIS

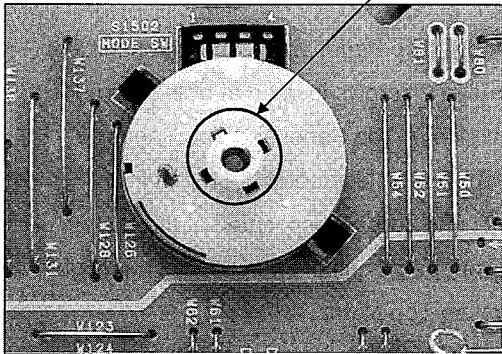
Click position of Position switch
(Check the phase alignment in Eject mode)

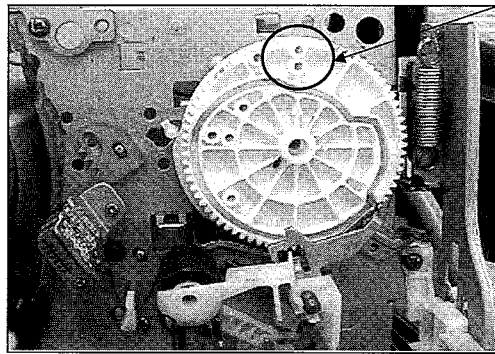
The hole of Main cam gear and the penetration hole of Mechanism chassis
(Check the phase alignment in Eject mode)

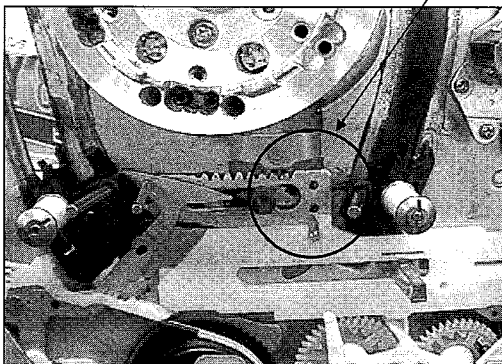
Loading rack

The Hole of loading rack and the penetration hole of Mechanism chassis
(Check the phase alignment in Eject mode)

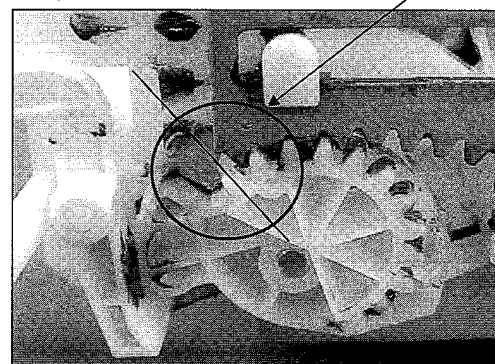
Wiper arm and Drive rack

Assign the hole of Drive rack and the hole of Wiper arm on the straight line.
(Check the phase alignment in Cassette down position)
